COLLEGE OF ENGINEERING, DESIGN, ART AND TECHNOLOGY  
(CEDAT)

CMG 8203: MASTERS PROJECT REPORT (PLAN B)

ASSESSING THE IMPACT OF SCOPE CREEP AND LOCAL SKILLED LABOR  
CONSTRAINTS ON SCHEDULE DELAYS: A CASE STUDY OF THE SAFARI 2  
APARTMENTS PROJECT, HODAN DISTRICT, MOGADISHU, SOMALIA

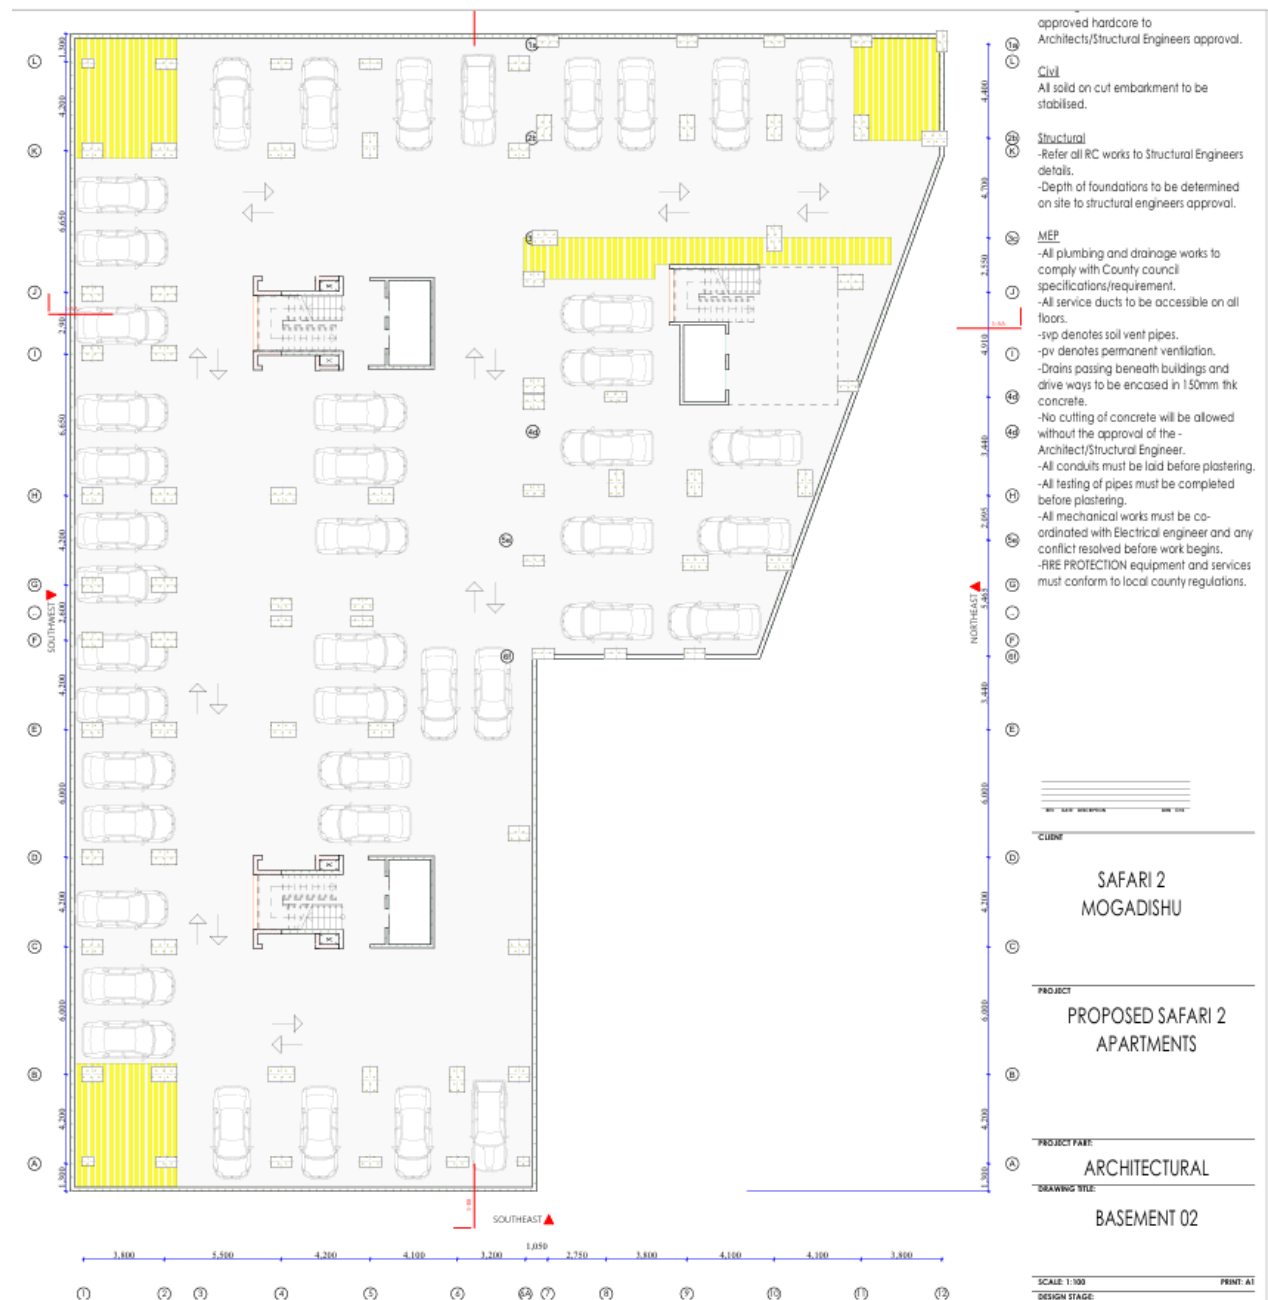
Figure 6: Basement 02 Floor Plan

The building is constructed using a reinforced concrete frame structural system consisting of reinforced concrete foundations, columns, beams, slabs, shear walls, and staircases, see appendix I and II. The development incorporates residential apartment units, lift systems, mechanical and electrical services, plumbing systems, external works, and architectural finishing works. The project was designed and executed to provide modern residential facilities that meet contemporary urban housing standards.

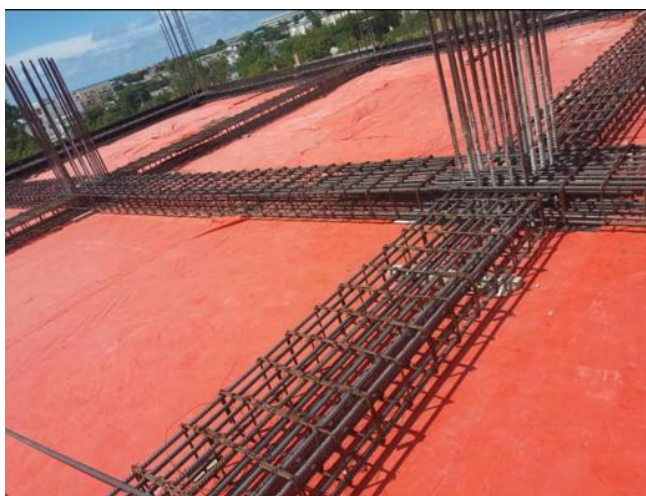
**Figure 12:Showing raft foundation, columns and beams**

2. Substructure works, including excavation and earthworks, foundation preparation, reinforced concrete raft foundation construction, basement retaining walls, foundation columns, lift shaft walls, and ground floor slab construction.

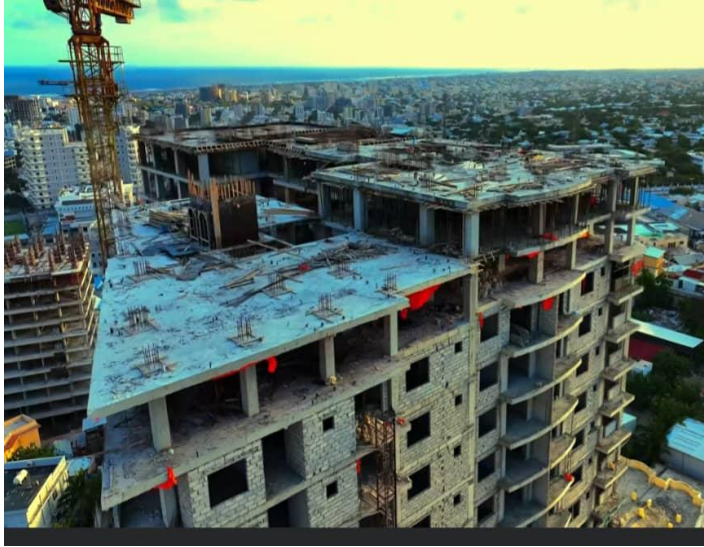
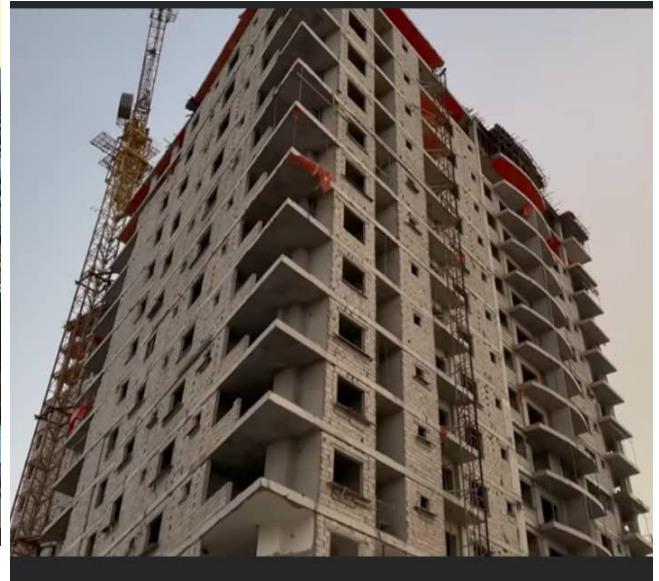
*Figure 13: Showing outside structure*

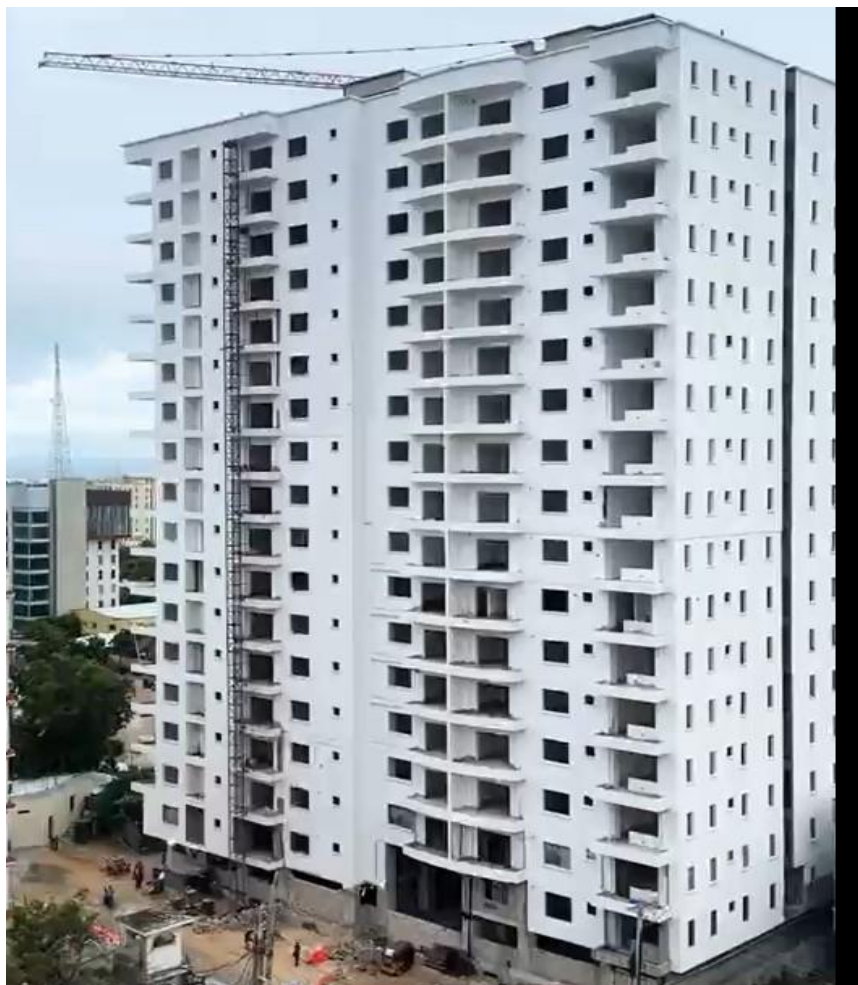
*Figure 14: Entire building structure*

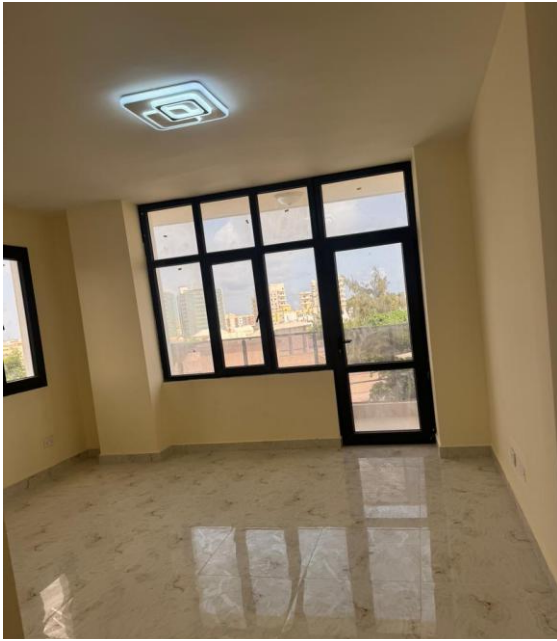
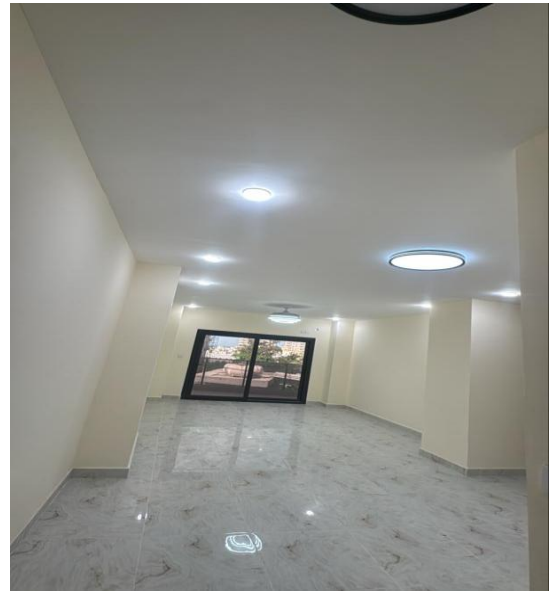
***Figure 15: Showing Interior finishes***
