**MAKERERE UNIVERSITY**

**MSC CONSTRUCTION MANAGEMENT**

**MASTERS PROJECT FIELD REPORT ON THE PROPOSED URF/PPDA HEAD OFFICE  
DEVELOPEMENT ON PLOT 39 NAKASERO ROAD  
KAMPALA**

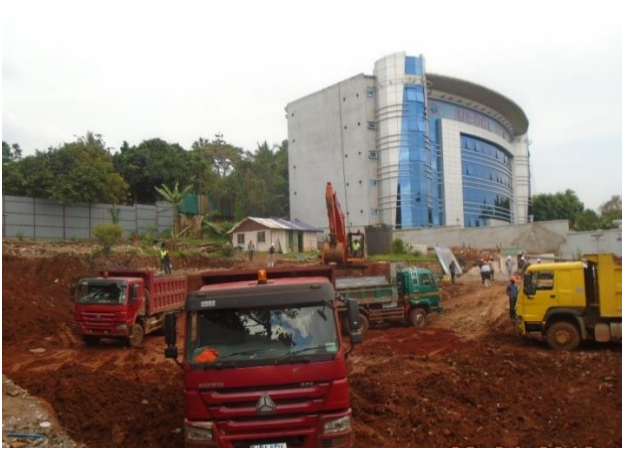
Figure 3: Site excavation to road level.

The excavated embankments were protected by applying short Crete concrete that was reinforced with chain link, and then the contractor proceeded with setting out for piles.

Setting out the extents of the piles and building, was done using coordinates method. Pegs were fixed at each four corner coordinates which were transferred to the Profile boards using nails, and building strings. Setting out was done based on architectural drawings but in close consultation with structural drawings as well.

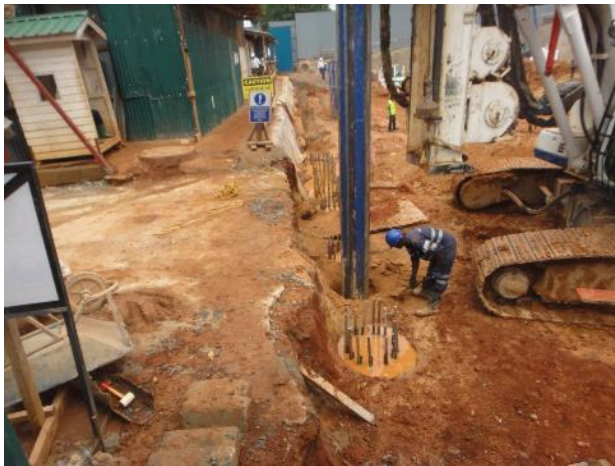
Fig5; Drilling for the pile pit.

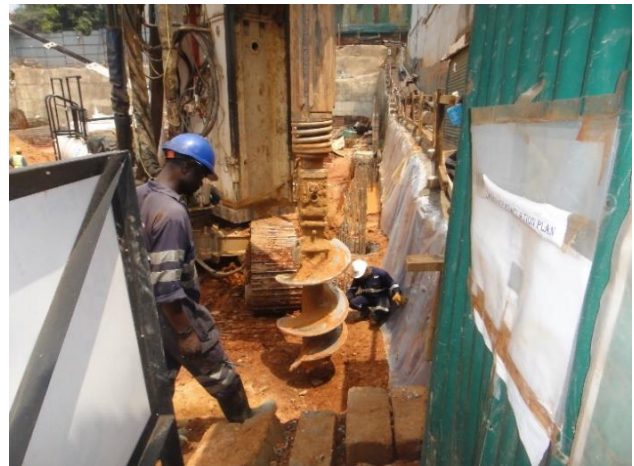
Fig6; Auger machine targeting the pile position.

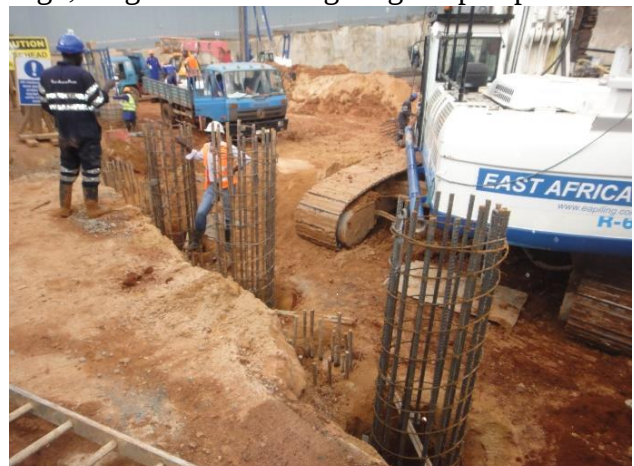
Fig8; Steel cages lowered down into pits.

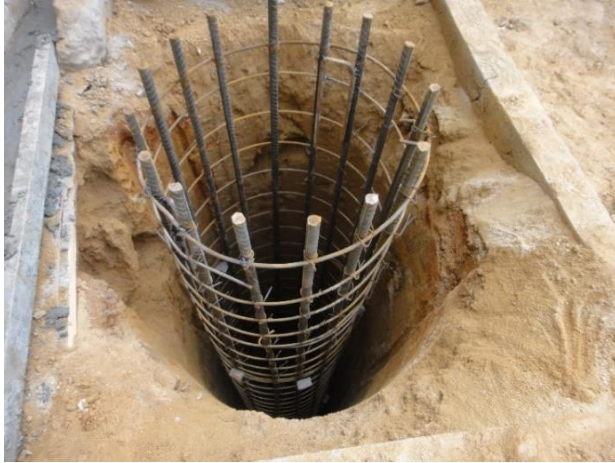
Fig9; Steel cage ready to receive concrete.

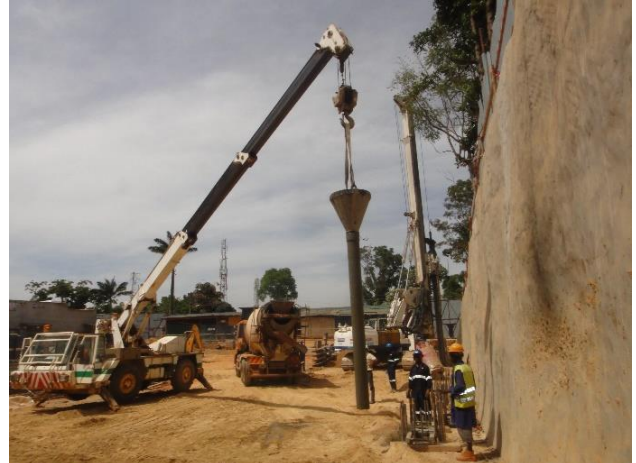
Fig10; Funnel being lowered into the steel cage.

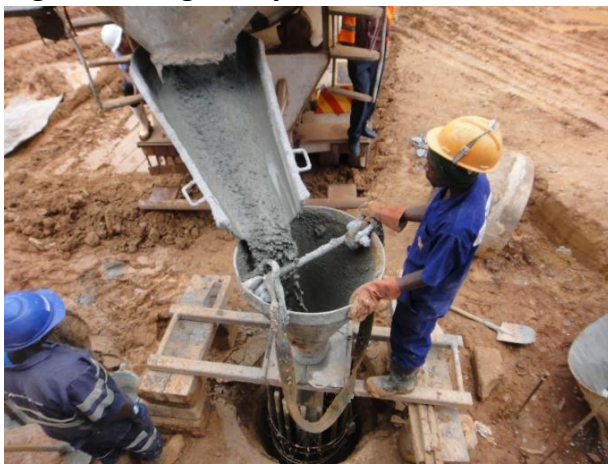
Fig11; Casting concrete to the pile.

Concrete grade 30 was used for all sub-structure concrete works. Curing was done for a minimum of 14 days to ensure adequate hydration and strength development for the concrete.

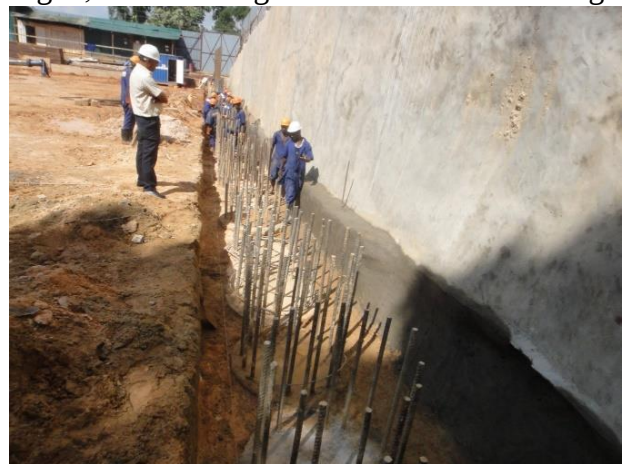
Fig12; Excavating for the pile cap beam.

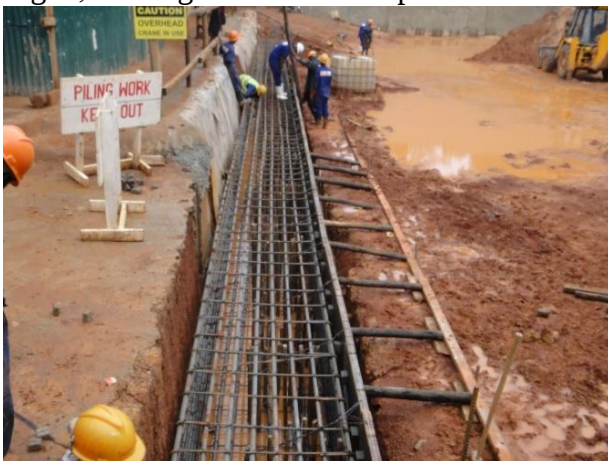
Fig13; Fixing steel and formwork to the pile beam

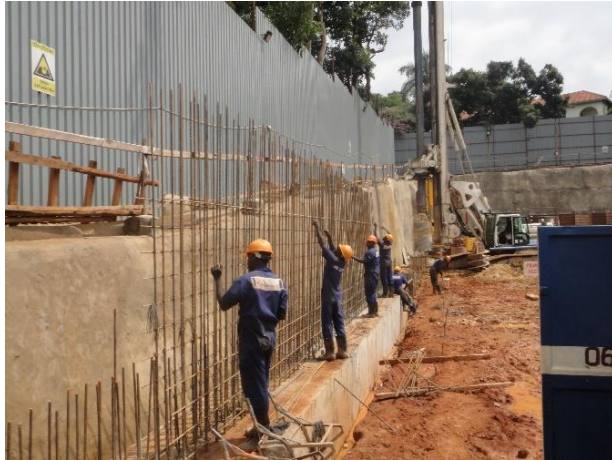
Fig15; Rebar works to the retaining wall.

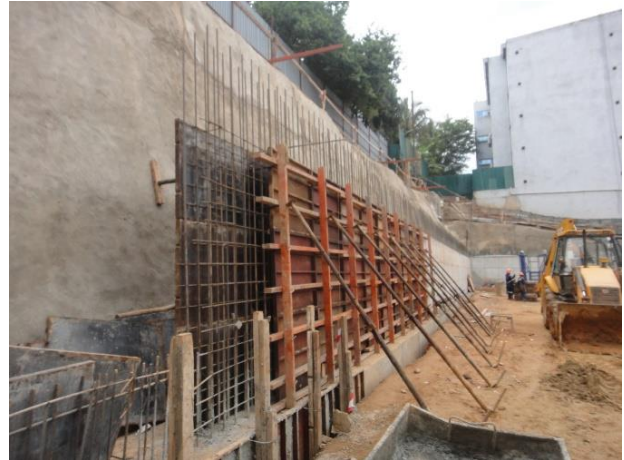
Fig16; Formwork to the retaining wall.

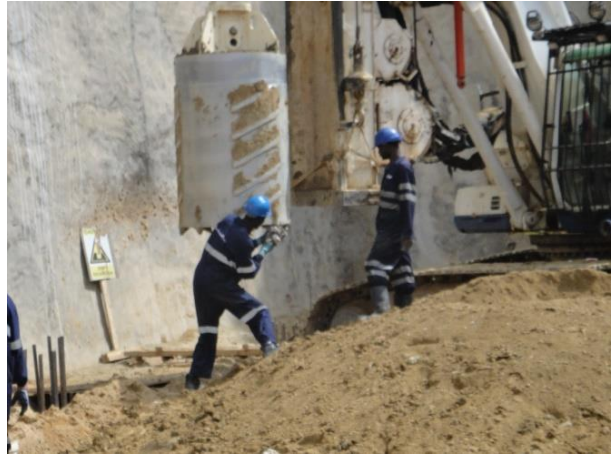
Fig18; Inserting a coring bucket to the pile pit.

The drilling machine would first drill the rock using the drilling auger and exchanged with another coring bucket that would help break the rocks into smaller particles, then the coring bucket is replaced with the cleaning bucket for removing the debris from the pile pit. The process of fixing steel and casting concrete to the pile was repeated as describe above.

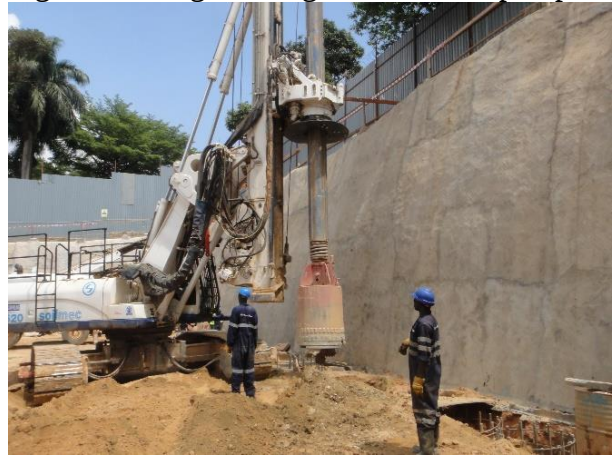
Fig20; Placing the cleaning bucket into the pit.

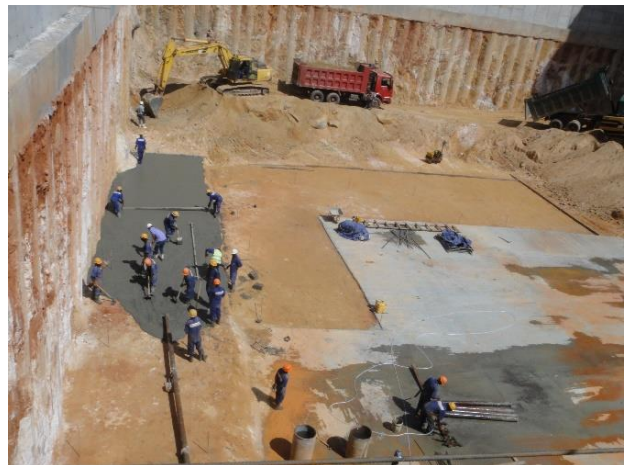
Fig22; Concrete blinding to basement3.

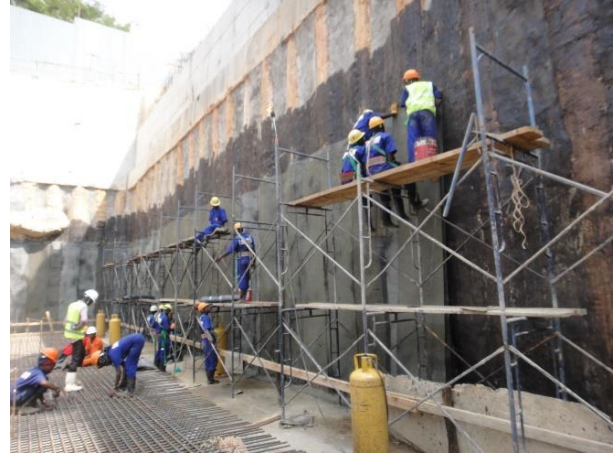
Fig24; Applying the APP membrane.

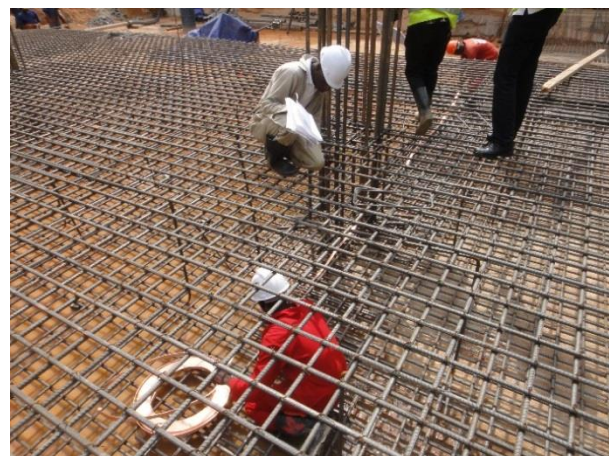
Fig 26; Laying the electrical copper tape.

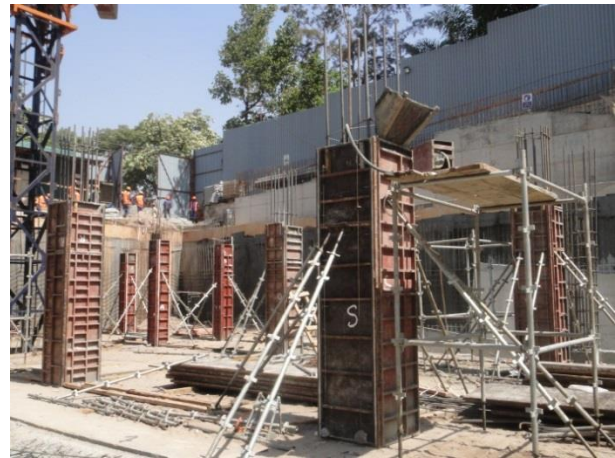
Fig 32; Formwork fixed to columns.

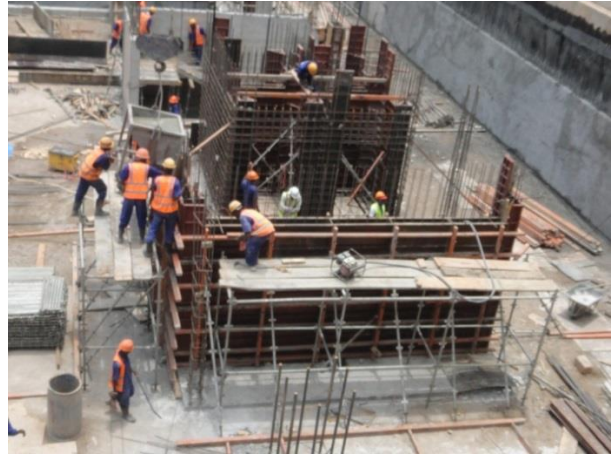
Fig 34; Formwork fixed to shear walls.

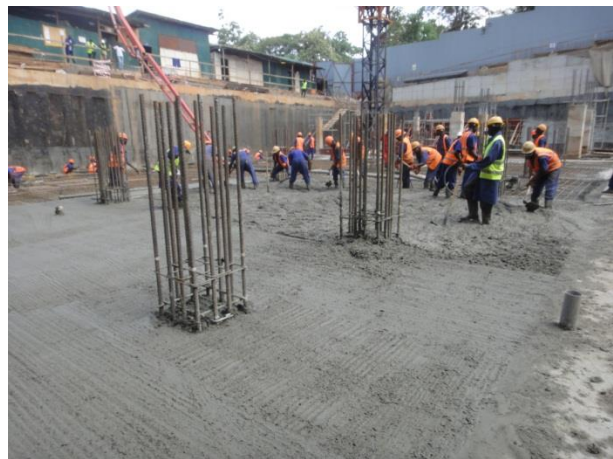
Fig 38; Casting concrete to solid slab.

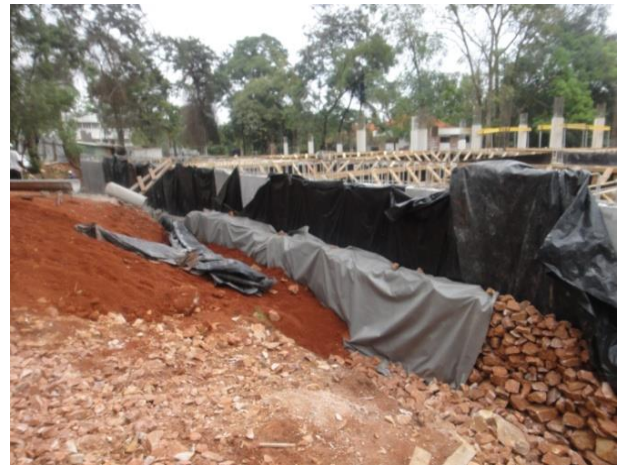
Fig 40; Construction of the dry wall.

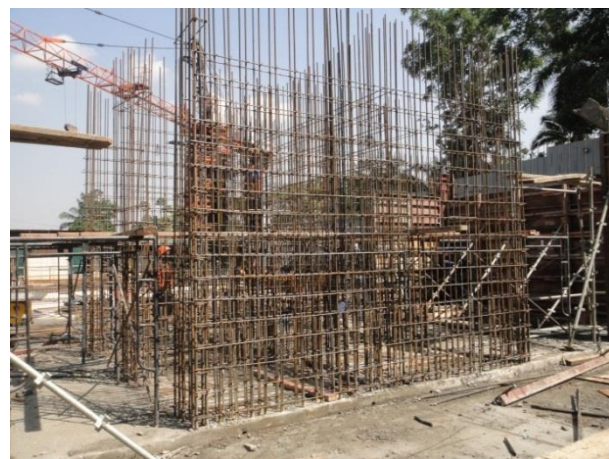
Fig 42; Rebar works to lift shaft walls.

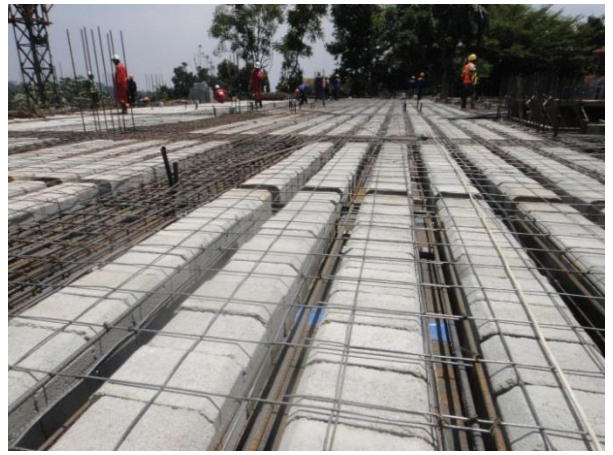
Fig 46; Maxpan blocks laid onto the slab deck.

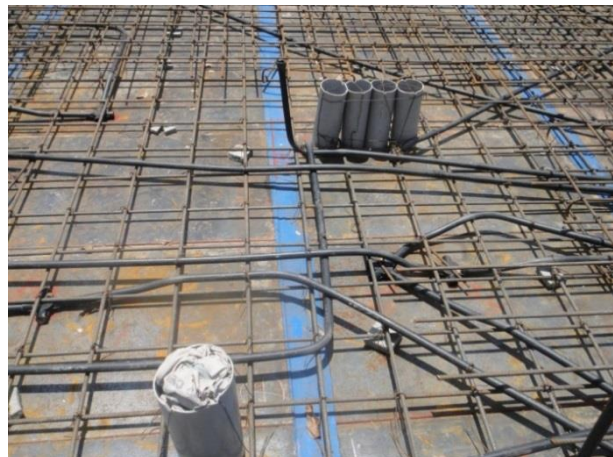
Fig 48; Sleeves and electrical conduits fixed.

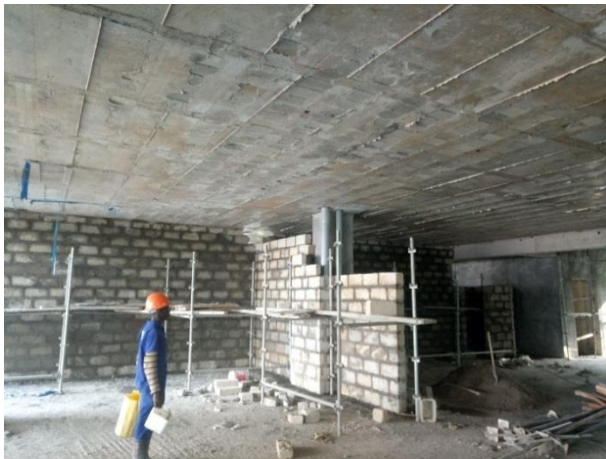
Fig 51; Block walling to office area.

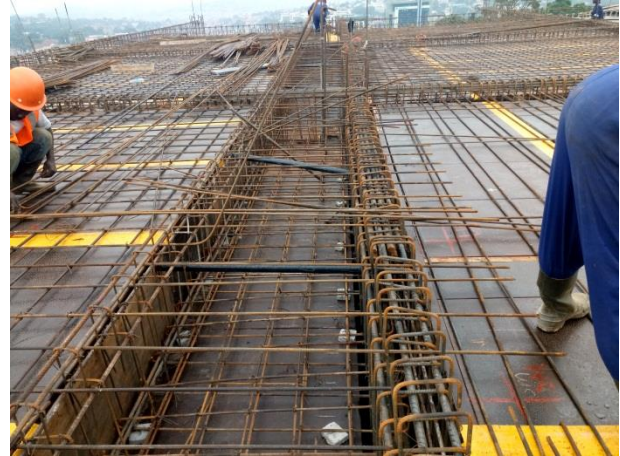
Fig 54; Rebar works to the roof gutter.

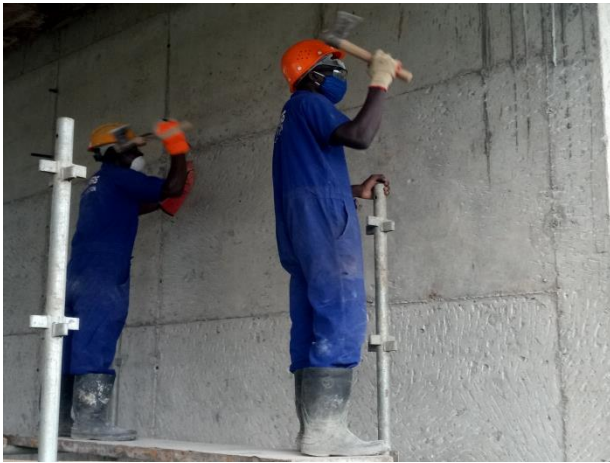
Fig 55; Hacking concrete surfaces.

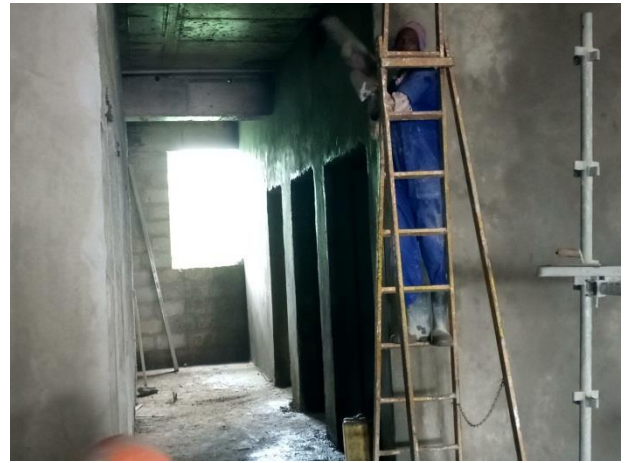
Fig 56; Plastering to walls.

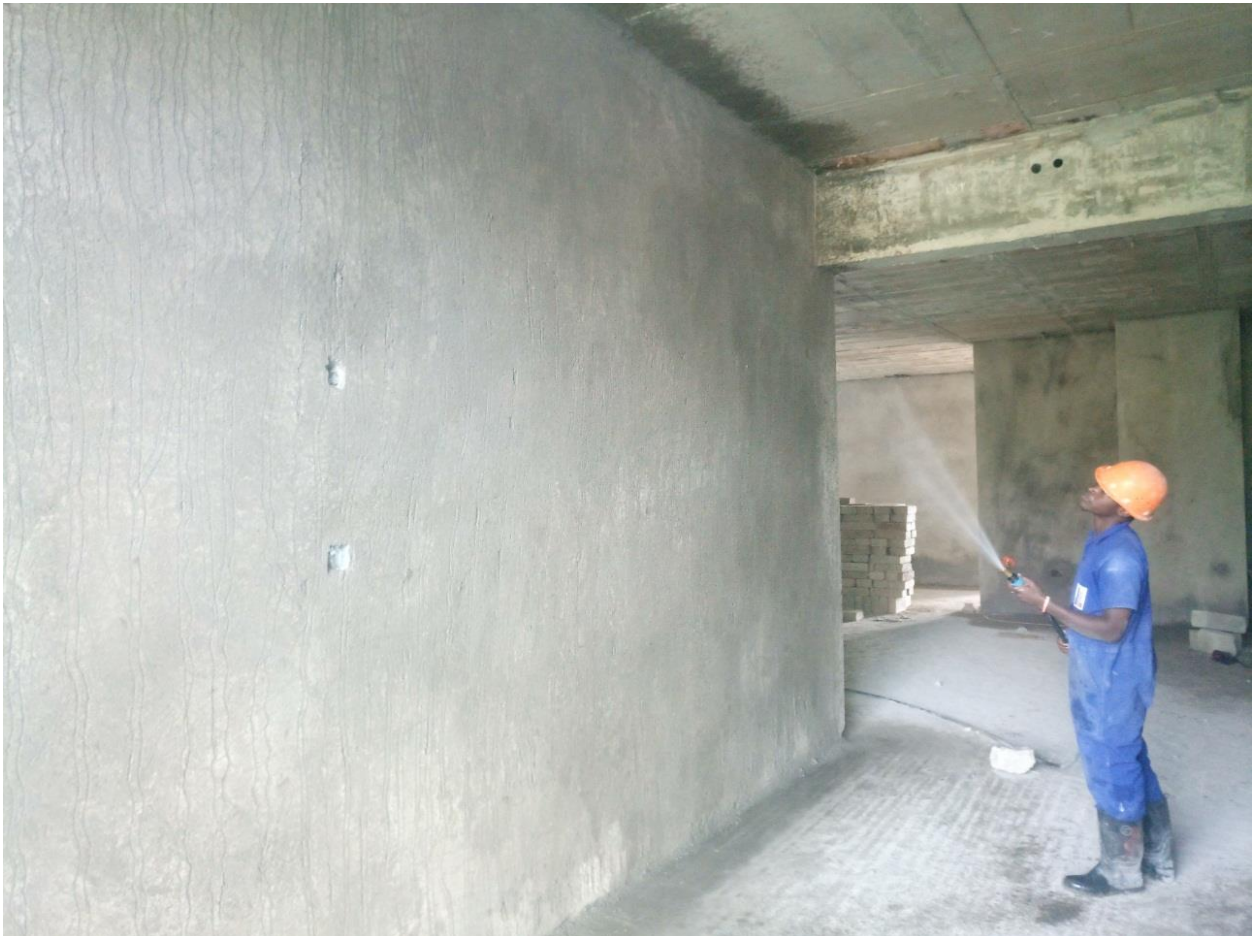
Fig 57; Curing to plaster works.

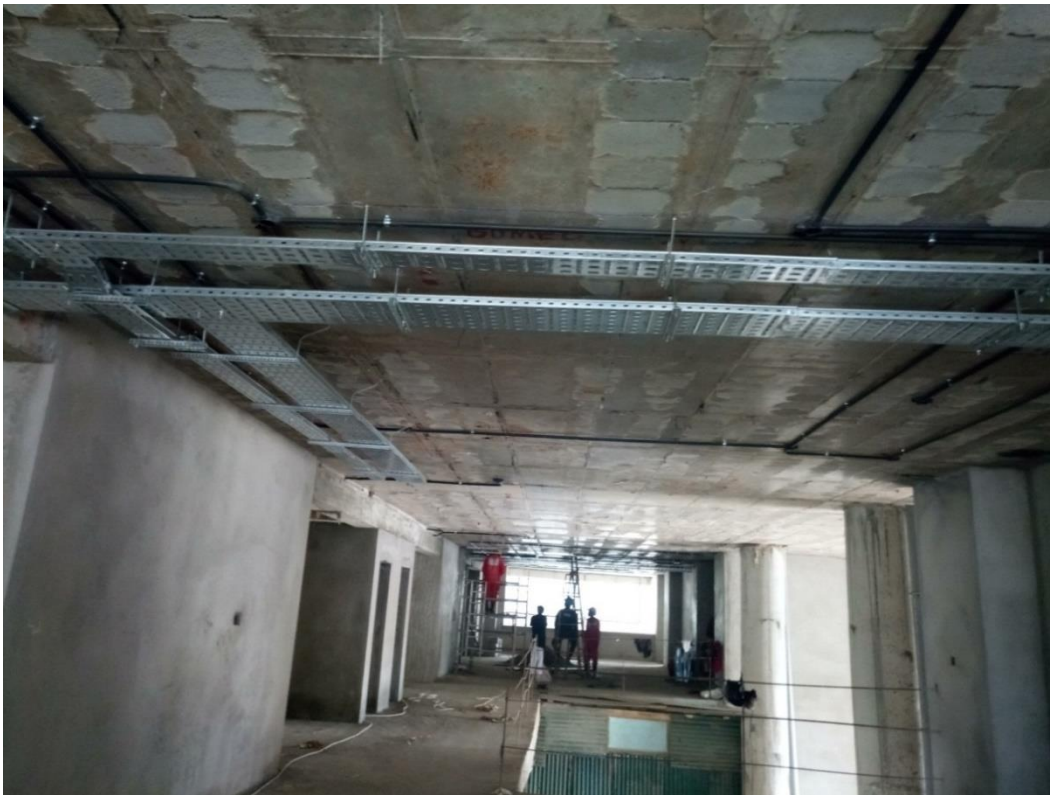
Fig 60; Cable trays fixed onto slab soffits.

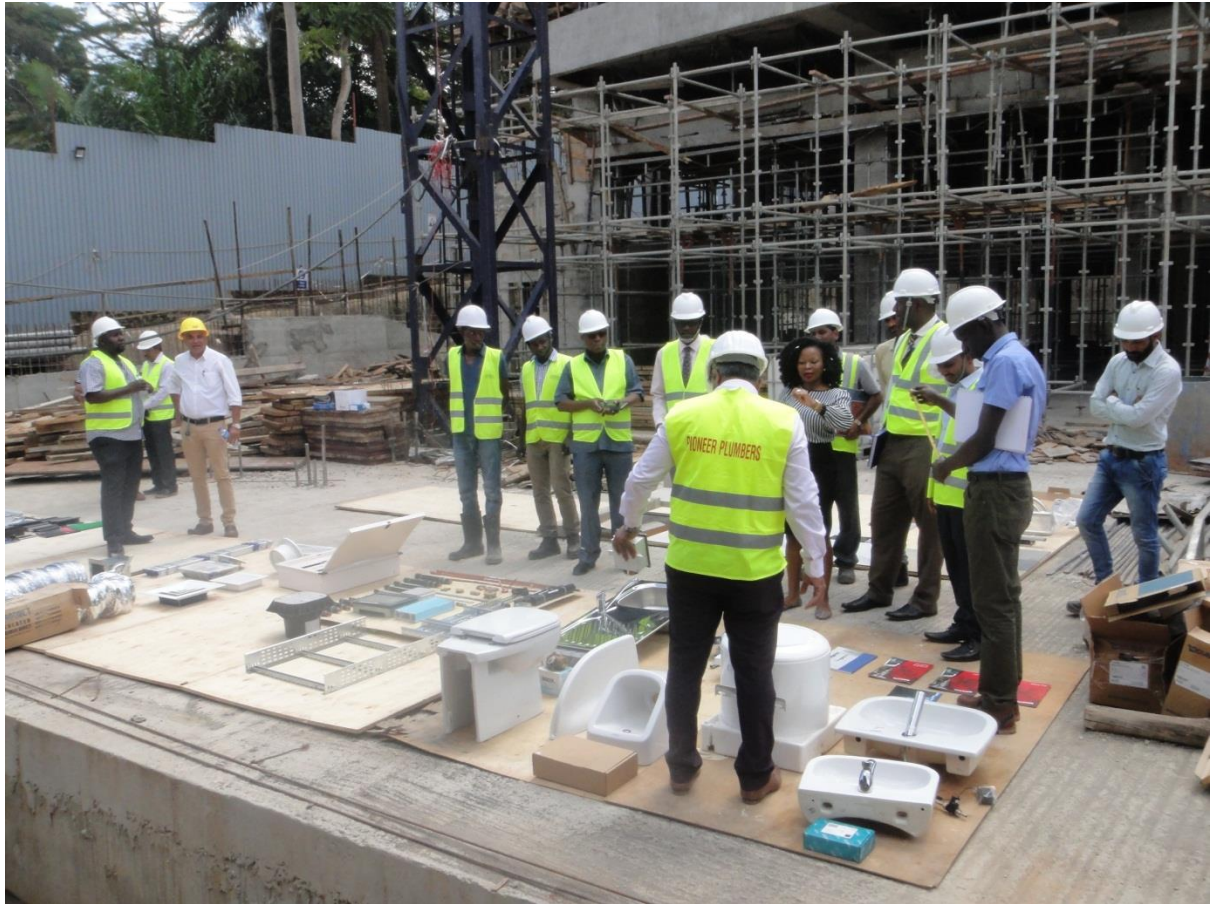
Fig 67; Team choosing and approving fixtures.

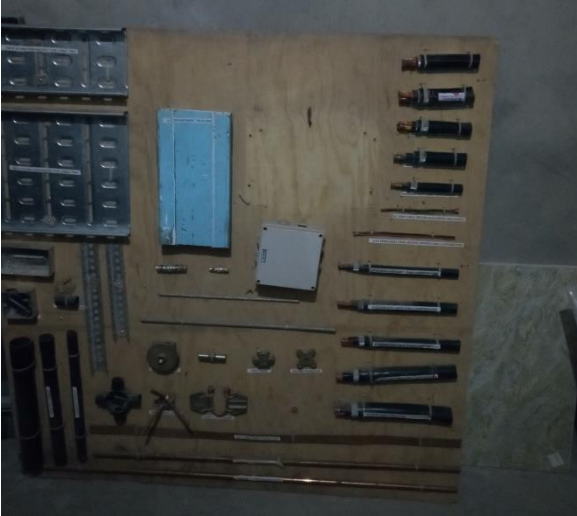
Fig 68; Electrical sample board

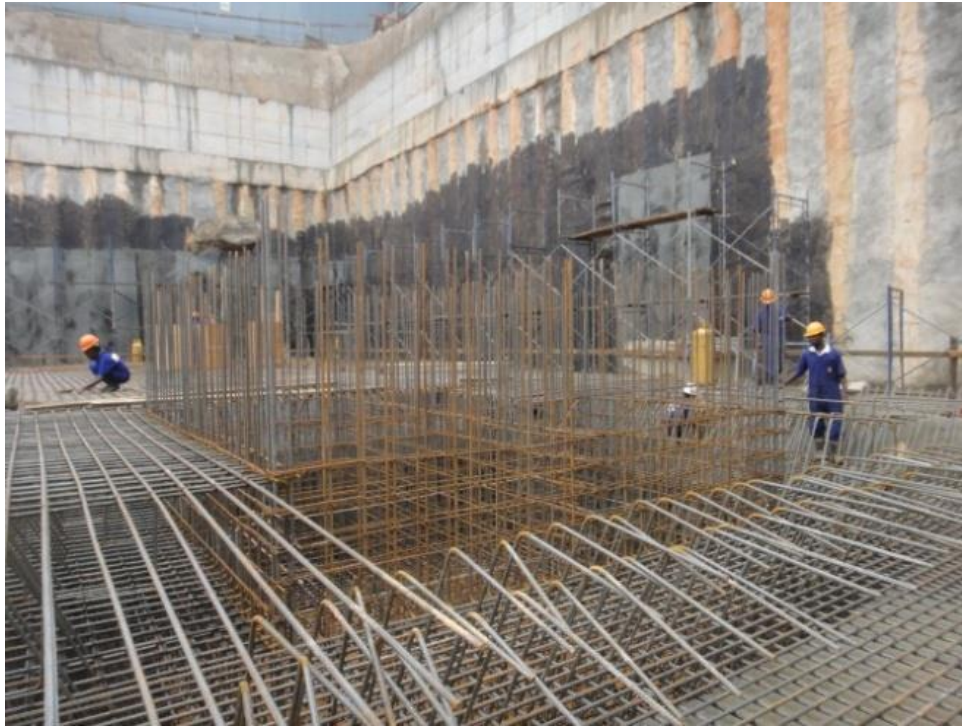
Fig 72; Starter bars for lift shaft walls.

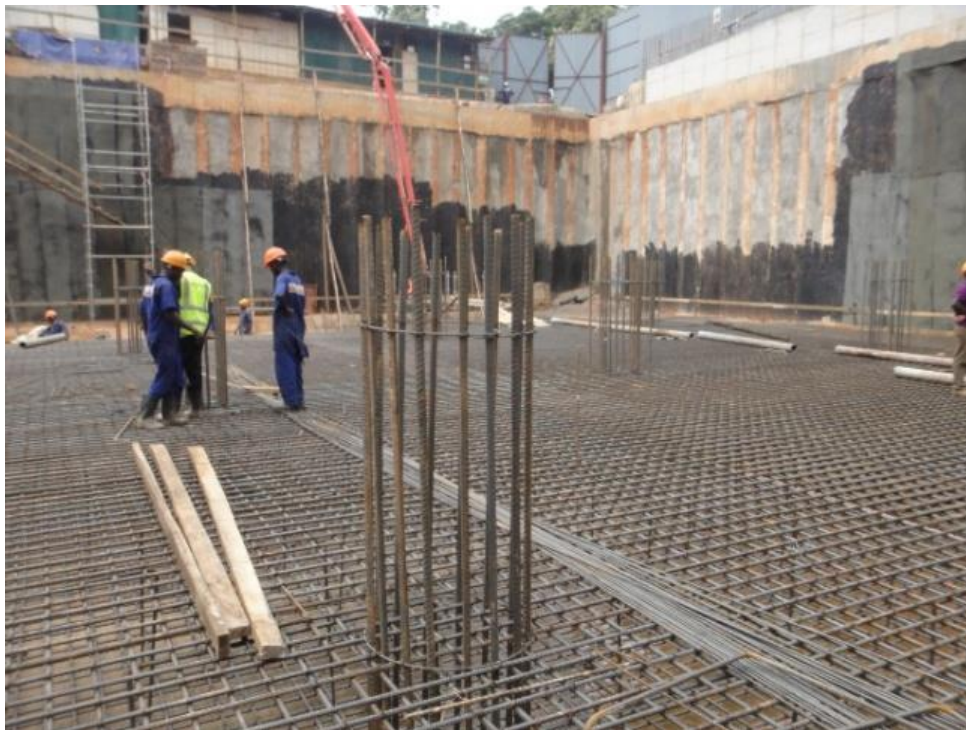
Fig 73; Columns bars fixed onto raft reinforcements.

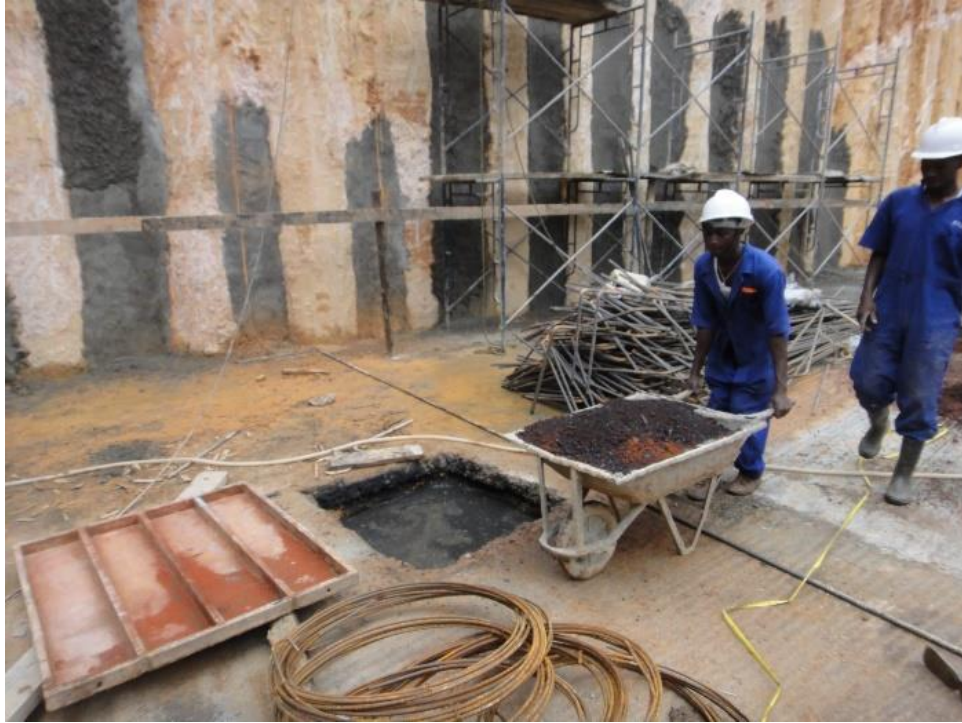
Fig 72; Putting charcoal in earthing pits.

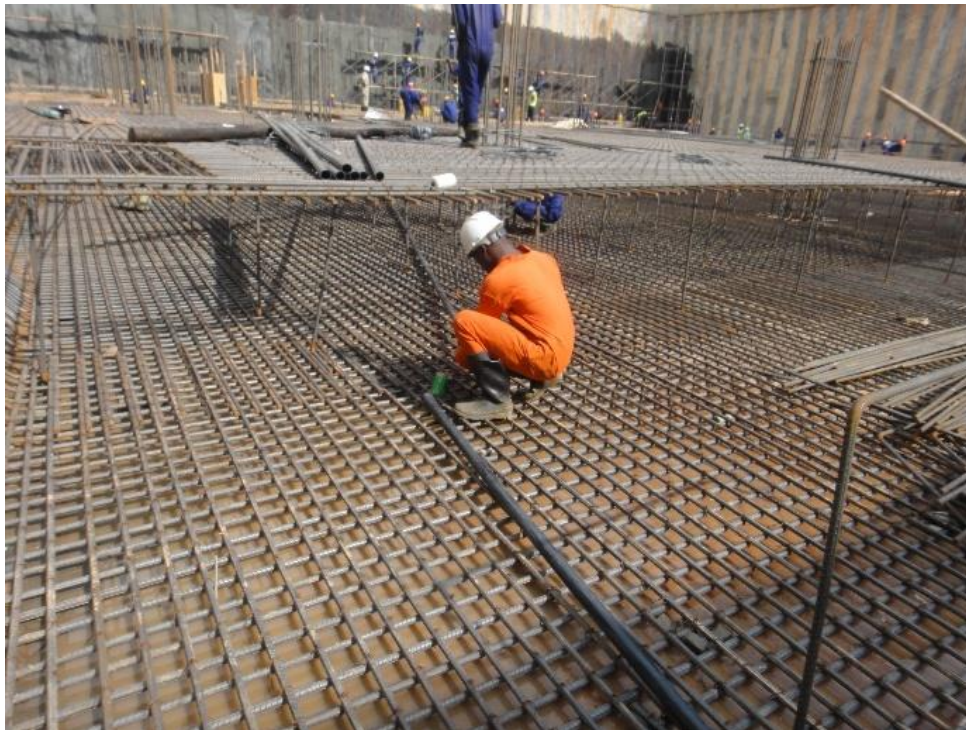
Fig 73; Laying electrical conduits into raft reinforcements.

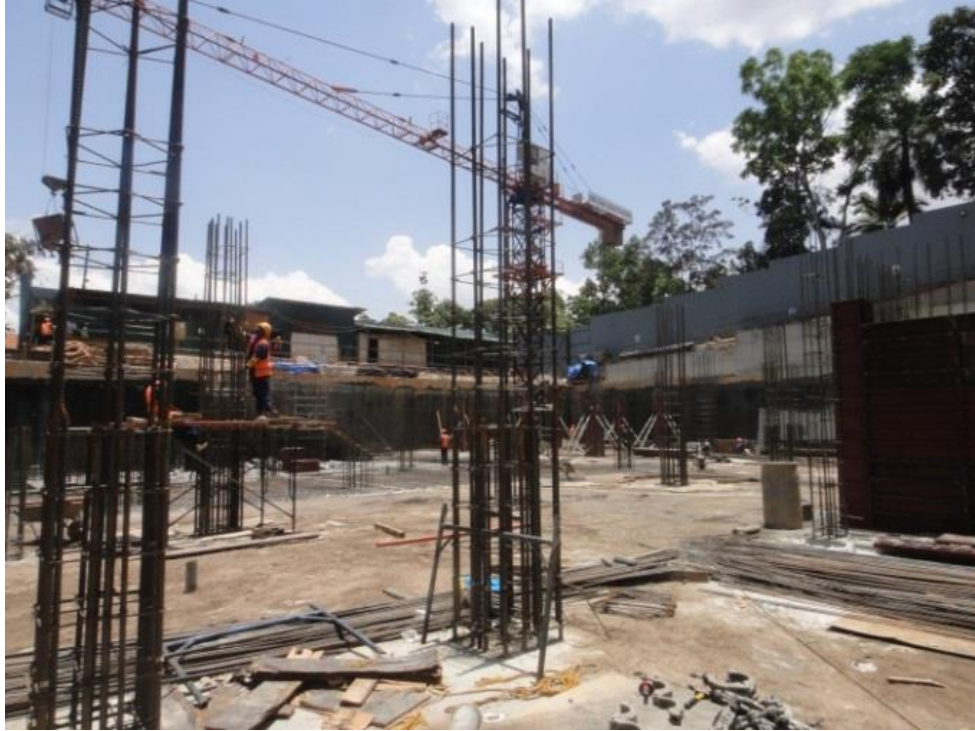
Fig 74; Column reinforcements fixed.

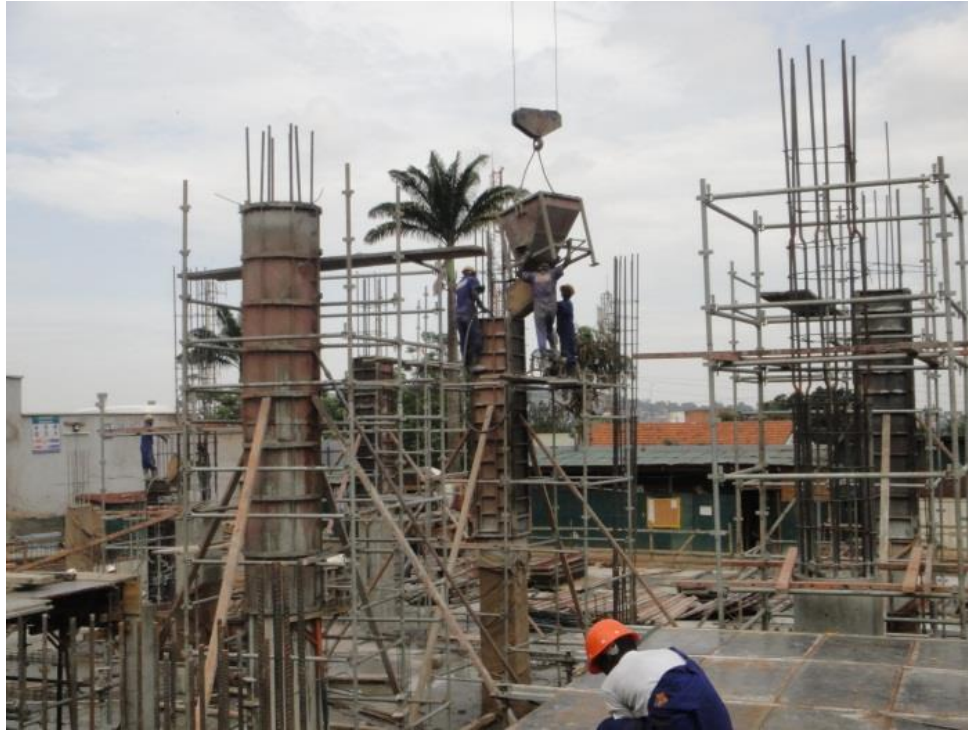
Fig 76; Casting concrete to columns.

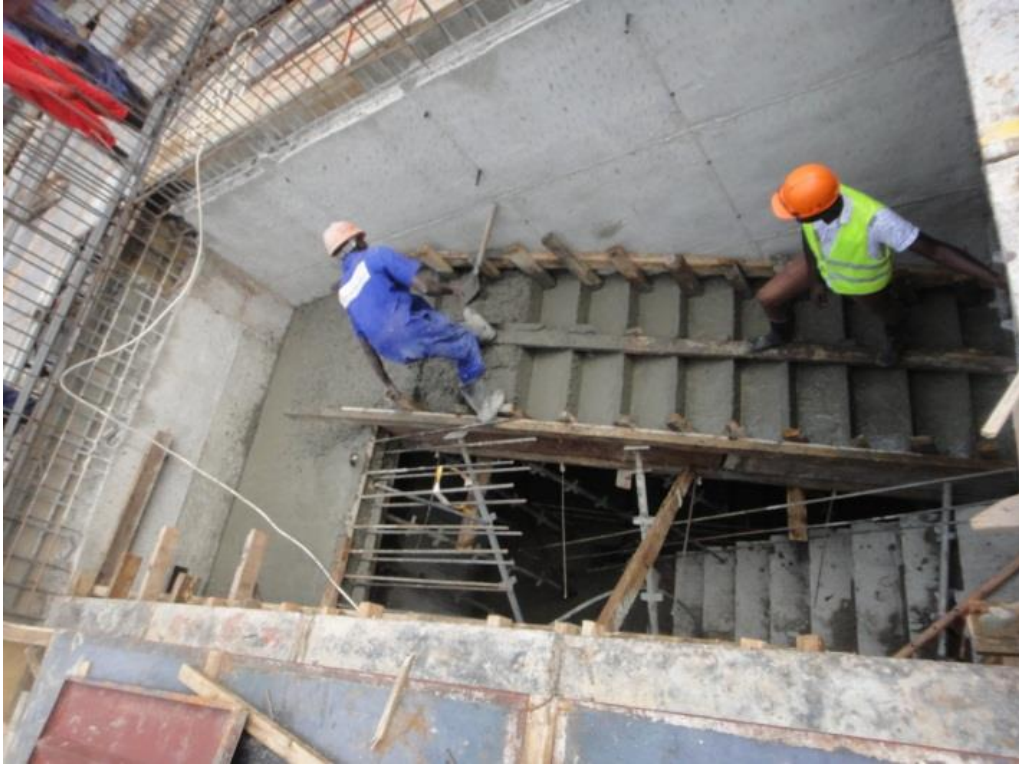
Fig 78; Casting concrete to staircases.

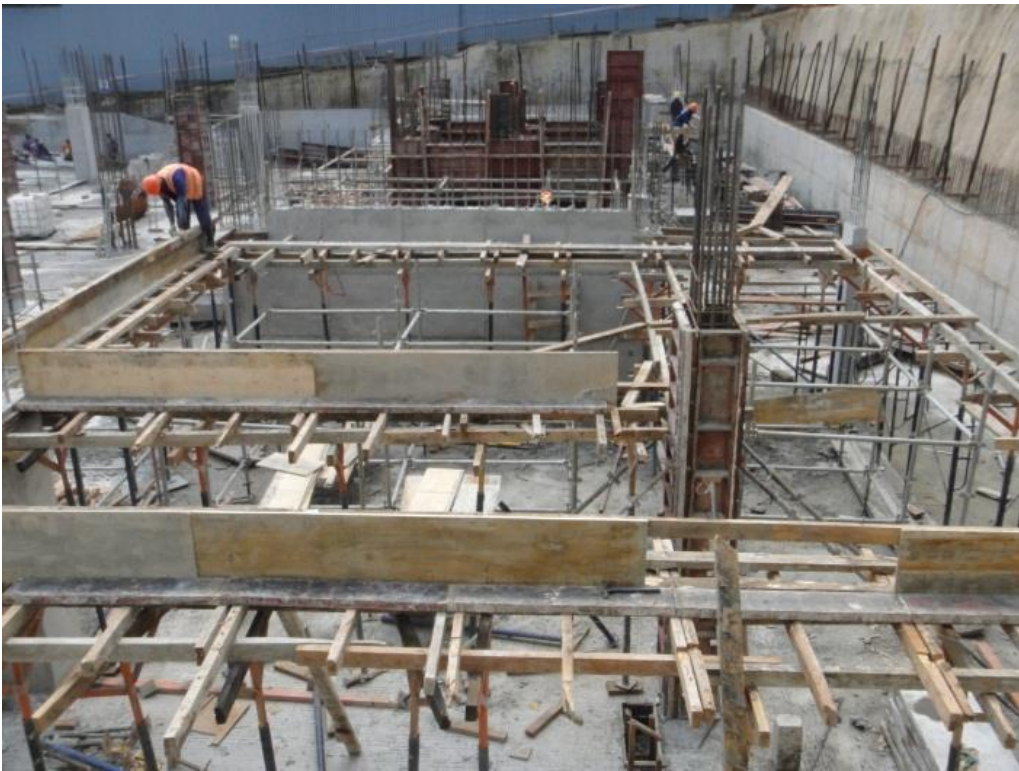
Fig 79; Fixing formwork to beams.

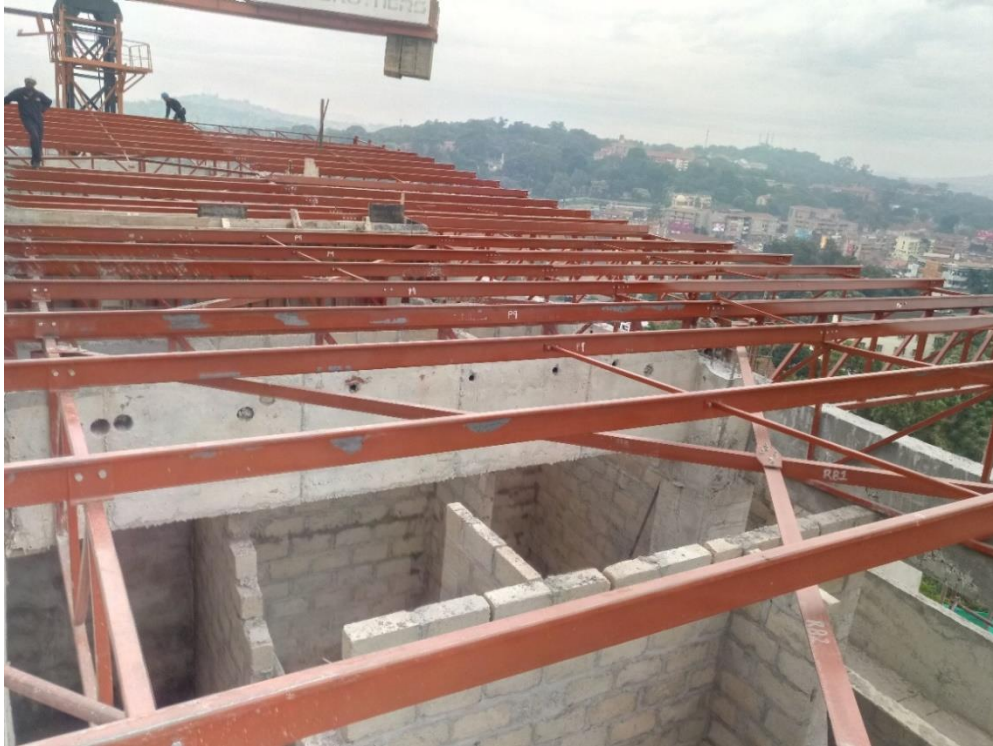
Fig 80; Purlins fixed onto roof girders.

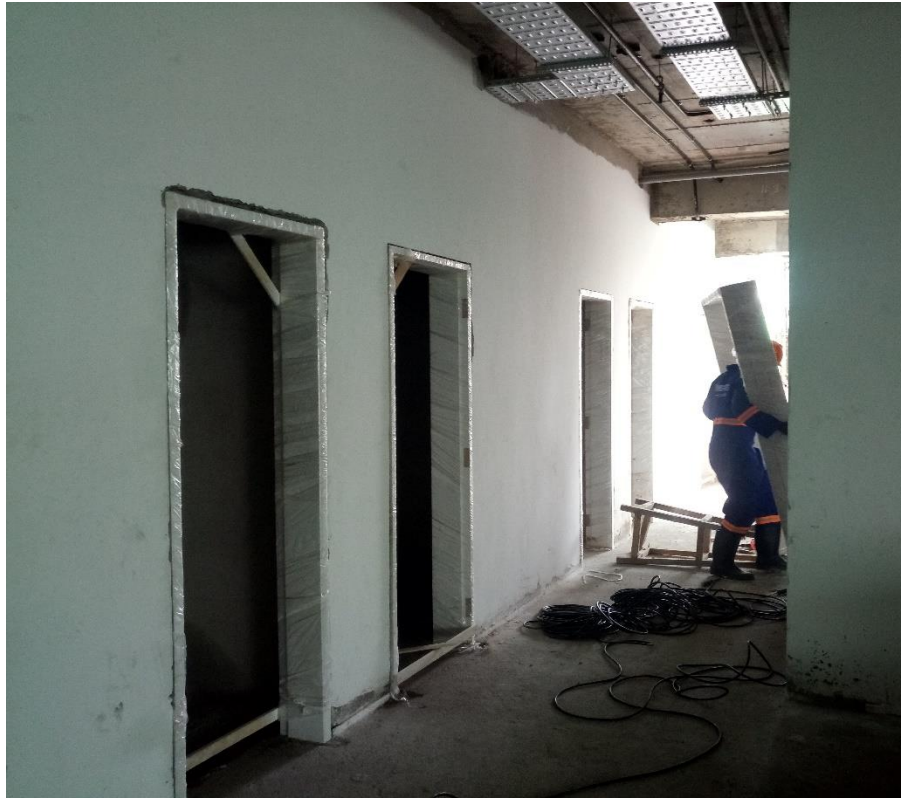
Fig 82; Fixing door frames.

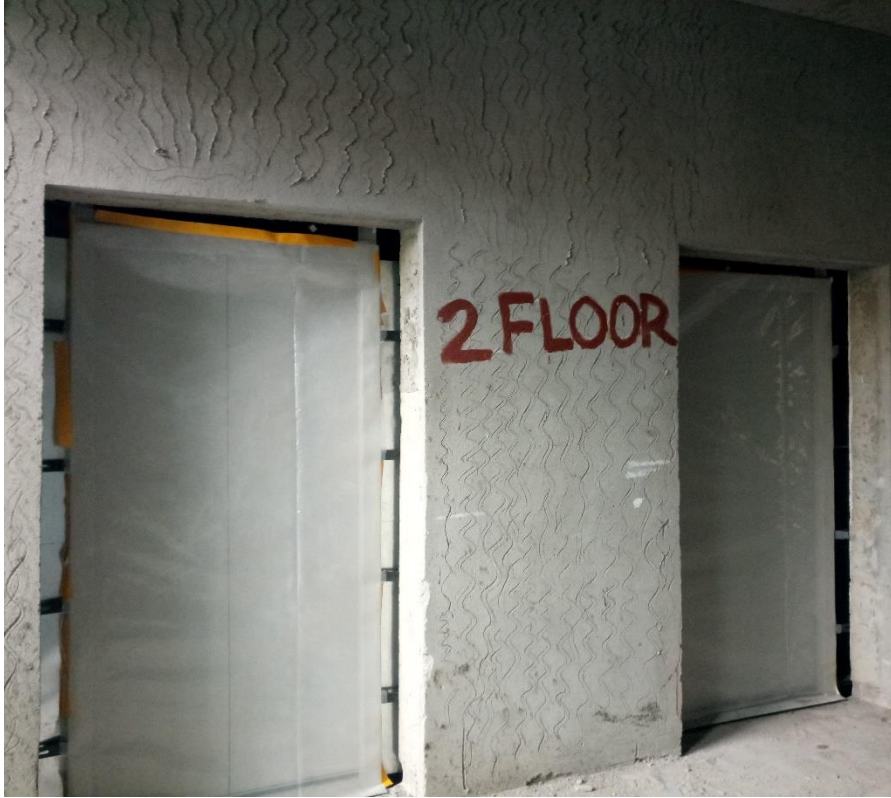
Fig 84; Fixing lift doors.

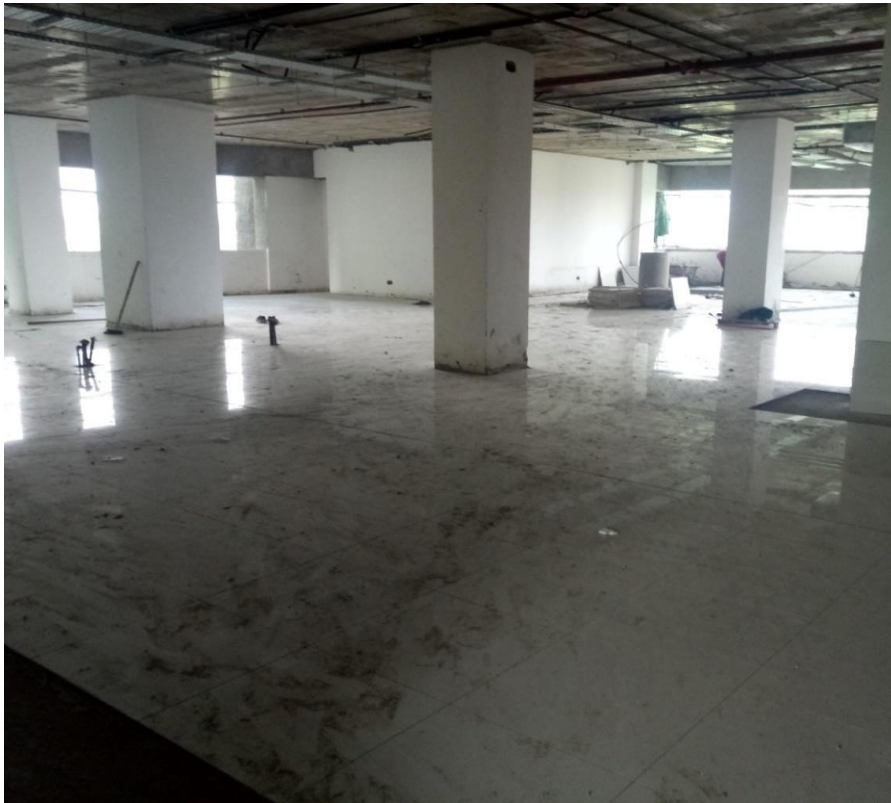
Fig 85; Laying floor tiles.

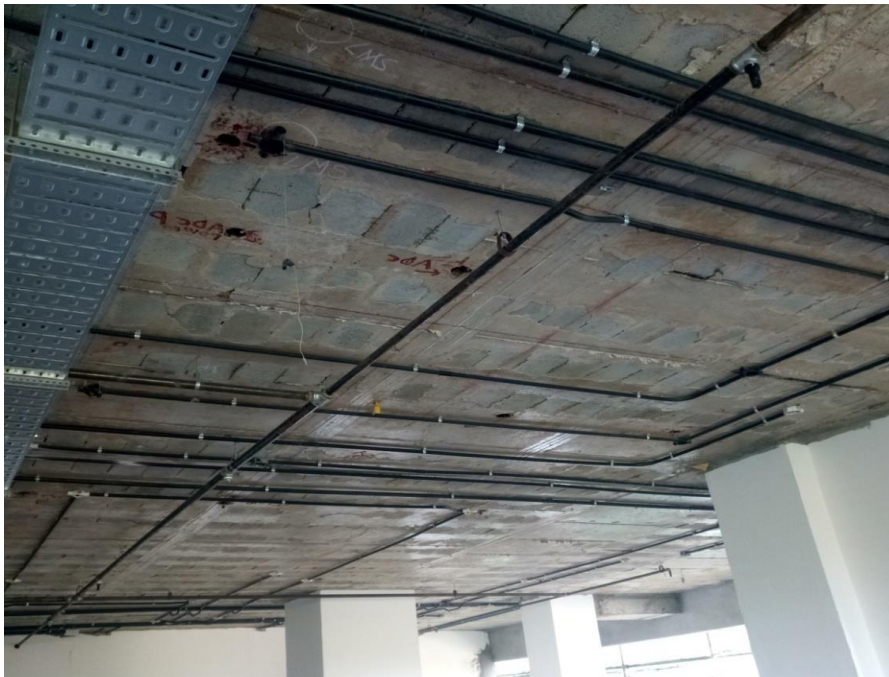
Fig 87; Sprinkler pipes fixed onto the slab soffit.

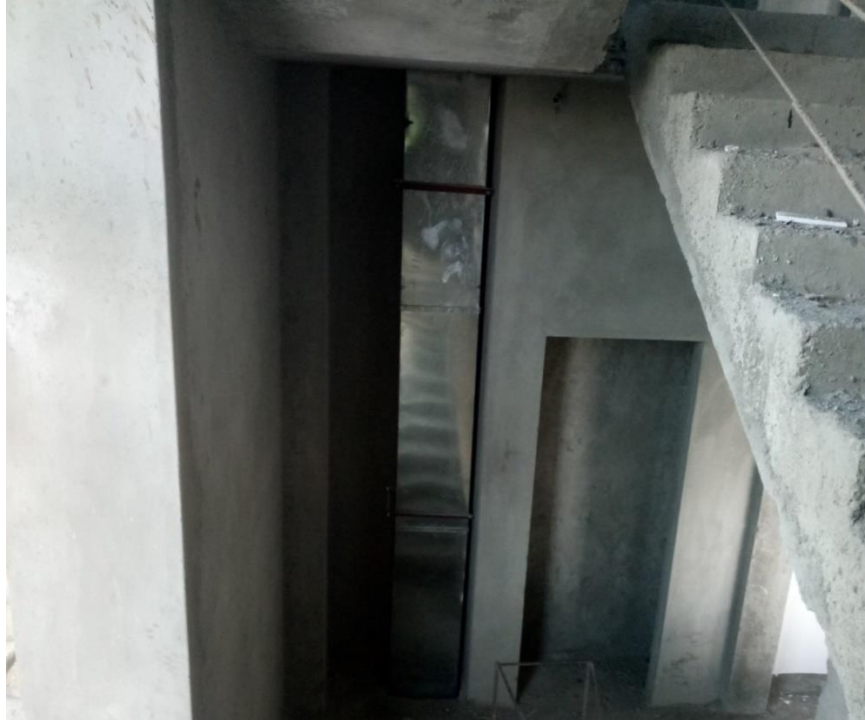
Fig 88; Pressurization ducts fixed along staircases.

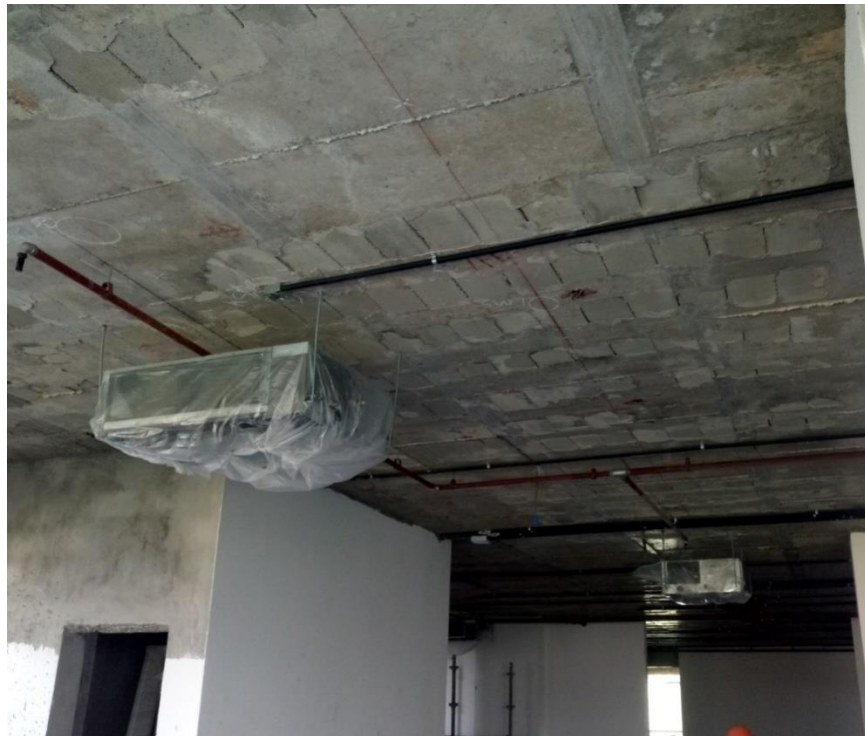
Fig 89; In door AC machines fixed onto slab soffits.

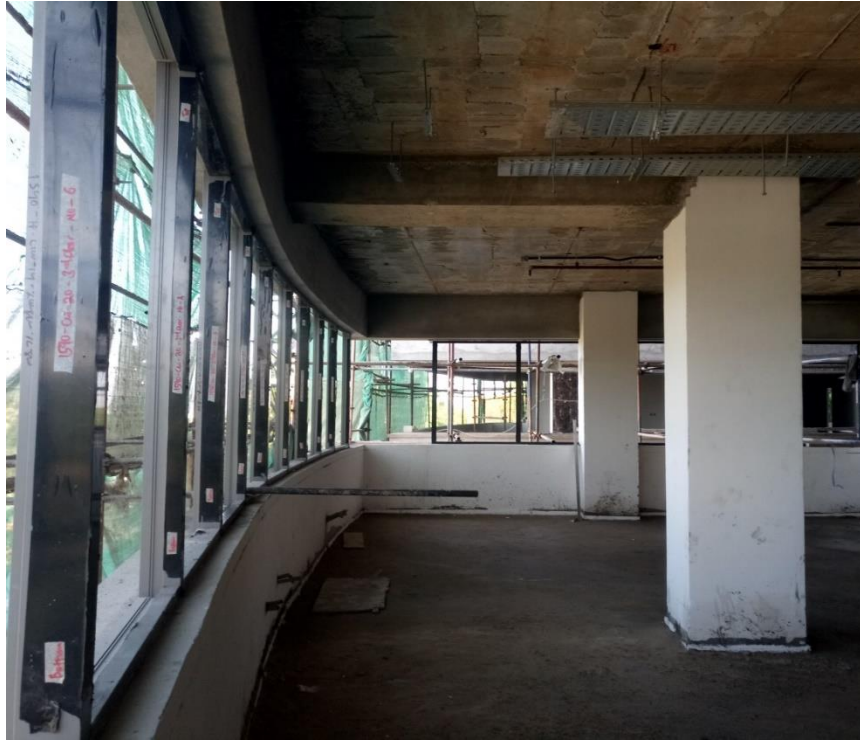
Fig 90; Fixing window aluminium frames.
