**MAKERERE UNIVERSITY**

**MSC CONSTRUCTION MANAGEMENT**

**MASTERS PROJECT FIELD REPORT ON THE PROPOSED URF/PPDA HEAD OFFICE  
DEVELOPEMENT ON PLOT 39 NAKASERO ROAD  
KAMPALA**

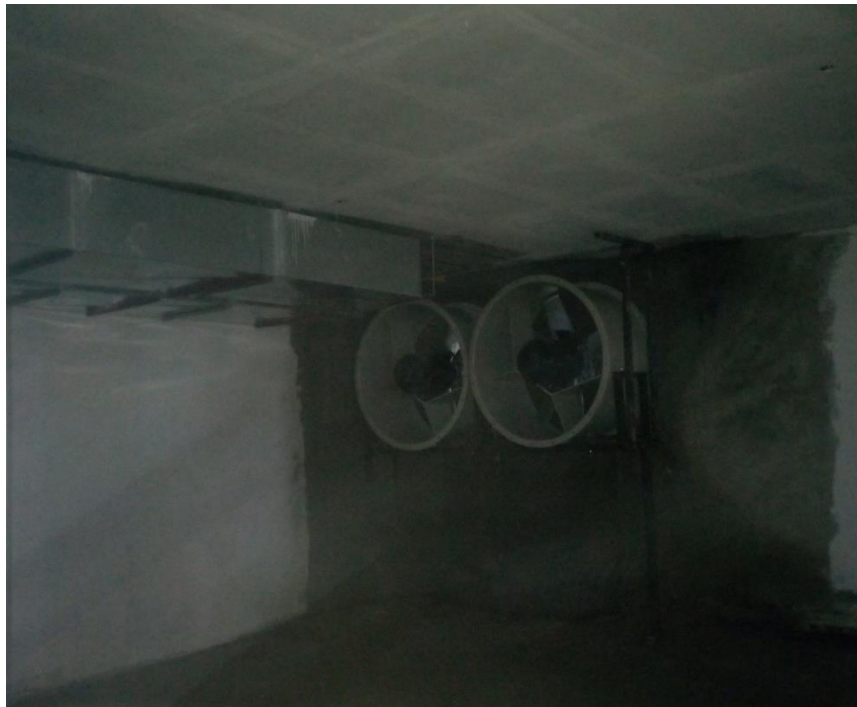
Fig 93; Basement extraction fans fixed.

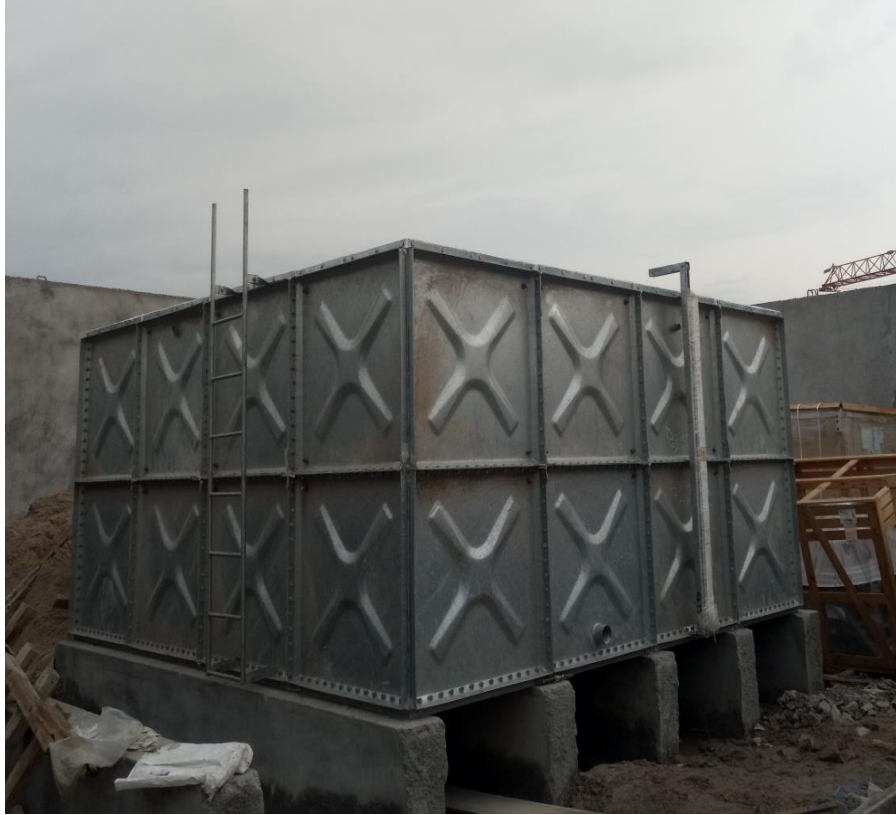
Fig 94; Assembling the water tank at the roof slab.
